## Case Study: Coletto

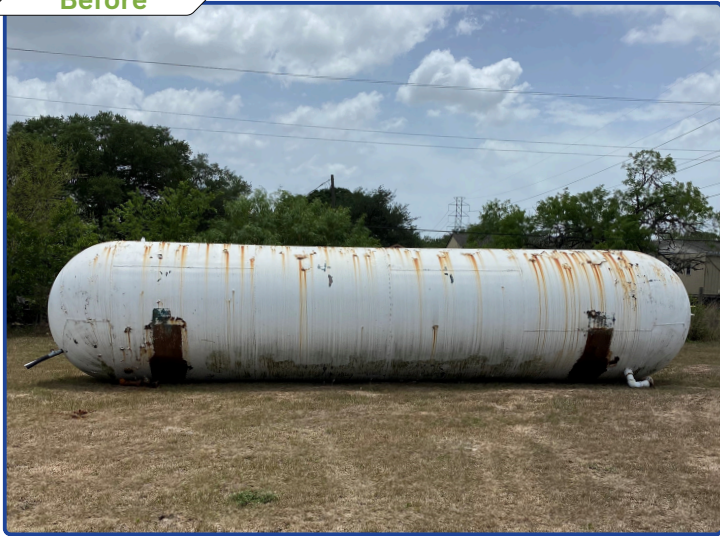
Before

In 2022, CSWR completed capital improvements on the Coletto Water system in Texas. When we purchased this system, it had been suffering from years of neglect and lack of reinvestment. The 44,000-gallon ground storage tank had severe corrosion and multiple leaks. The hydropneumatic tank also faced severe corrosion and had no access hatch, rendering an interior inspection of the tank impossible. CSWR removed the ground storage tank and installed a new fiberglass tank. The hydropneumatic tank was also replaced.
